Echocardiographic Assessment of Aortic Valve Prosthesis

Susan Wilansky, MD,
FRCP(C), FACC, FASE
Mayo Clinic, AZ

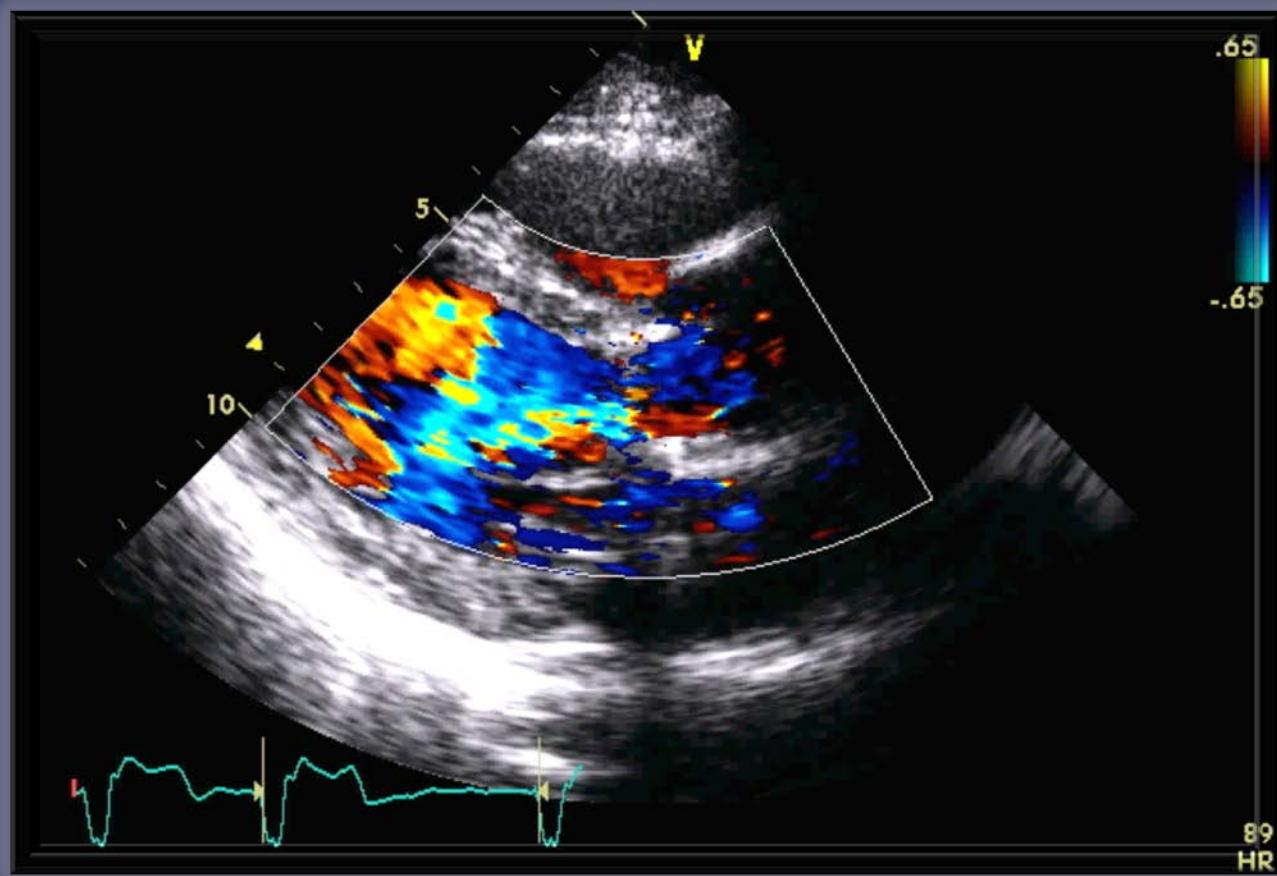
LV End Diastole 50mm, ESD 32mm

Septum 12mm
Wall thickness

Posterior 12mm
LV function
LVEF 60%

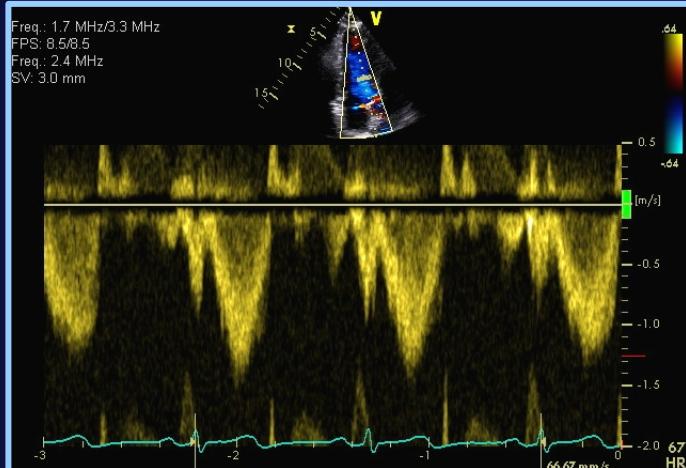
Dimensionless Index: DVI

$$\frac{\text{PW}_{\text{LVOT}}}{\text{CW}_{\text{AS}}}$$

Normal
 $\geq .30$

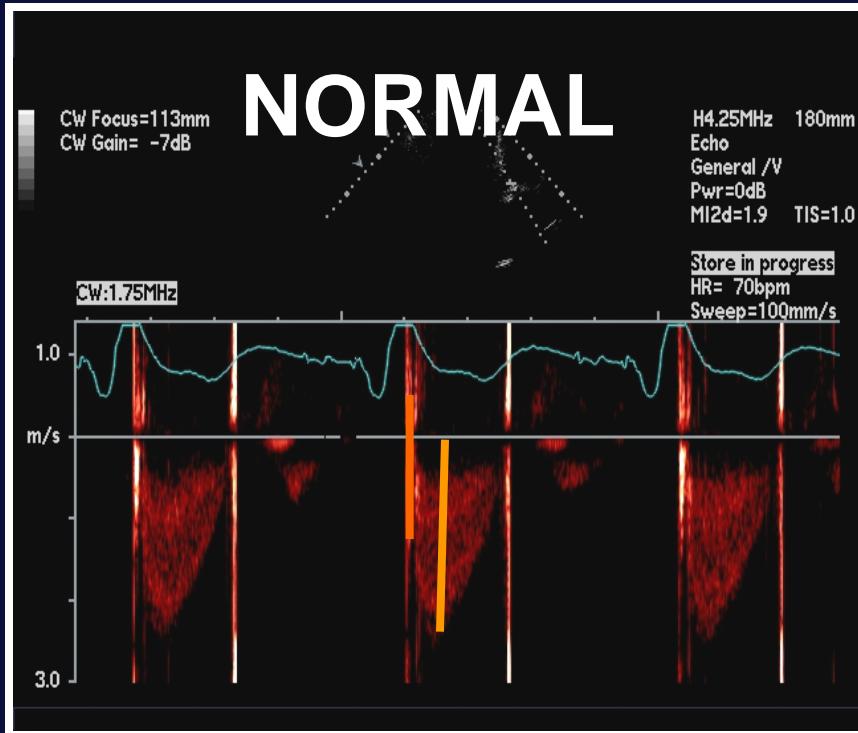
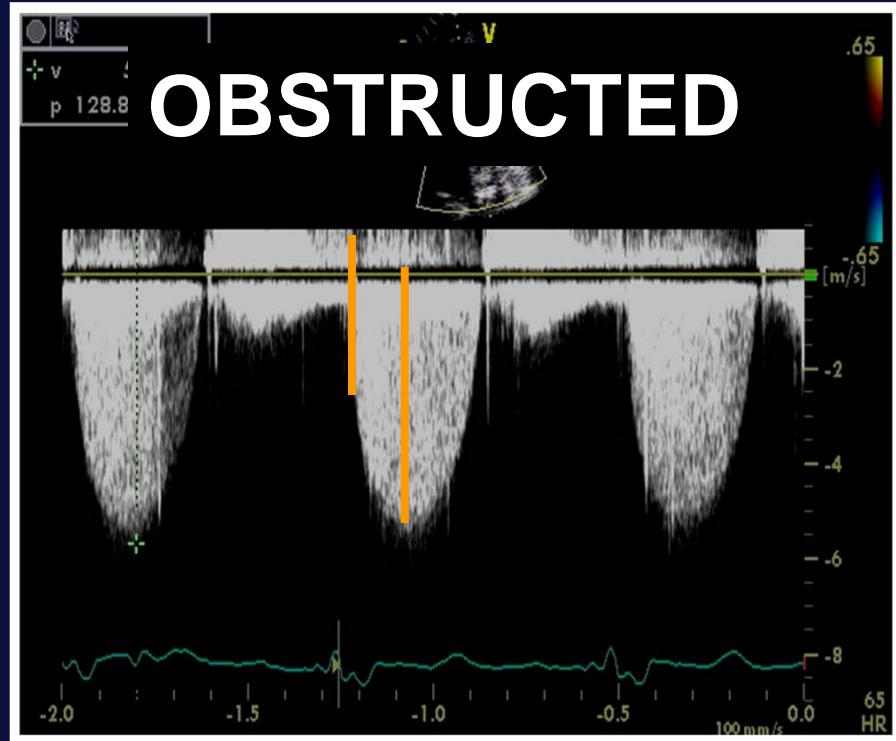
**Gradient
(mmHg)**

14

68

DVI

0.52

0.22

AT (ms)

70

177

AT/ET

Normal: $\leq 0.25 \pm 0.05$

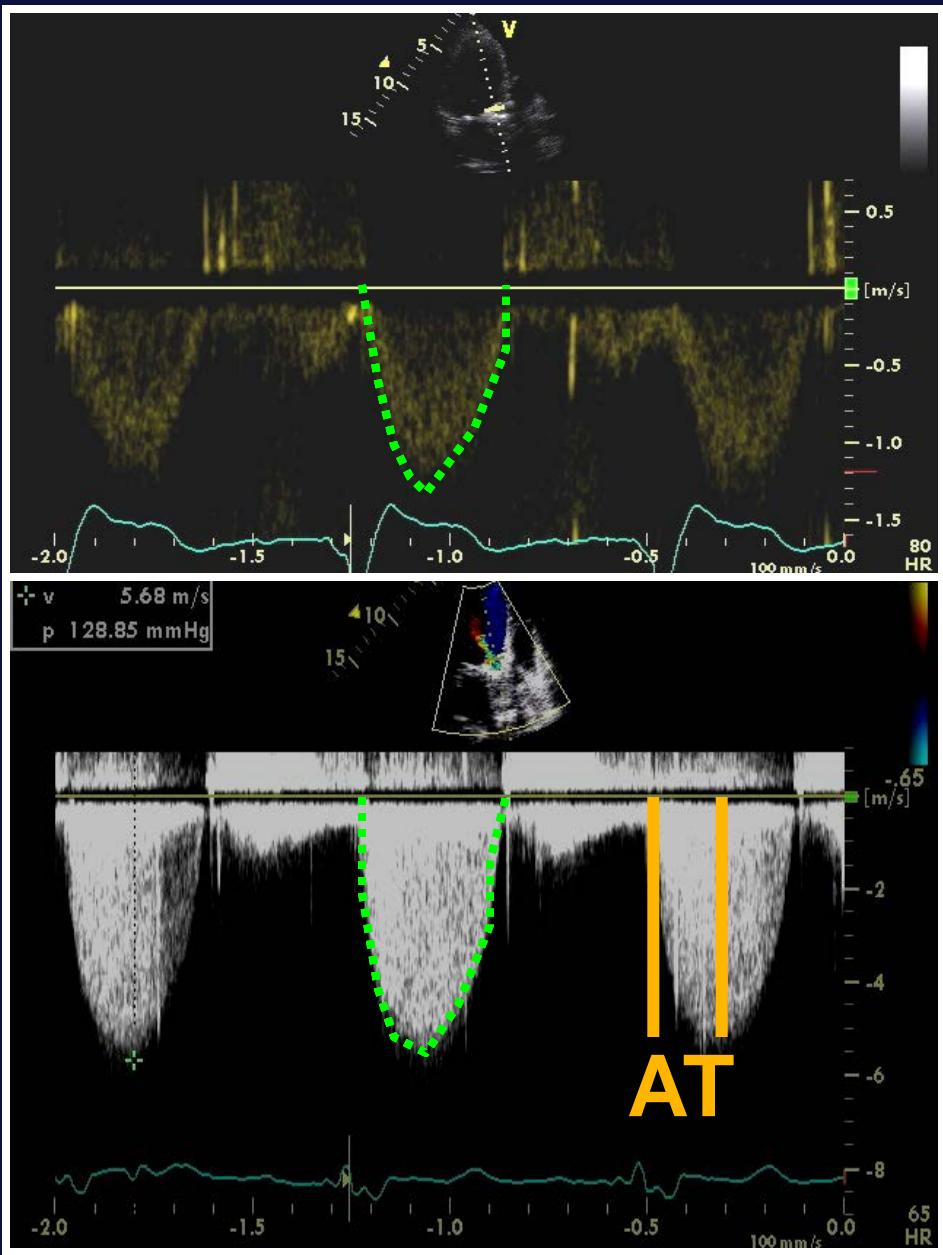
DVI : 0.22

AT : 177

AVA: 0.59 cm²

Expected gradients
for normal # 21 St.
Jude AVR:
Mean gradient 15 ± 5
EOA: 2 ± 0.7 cm²

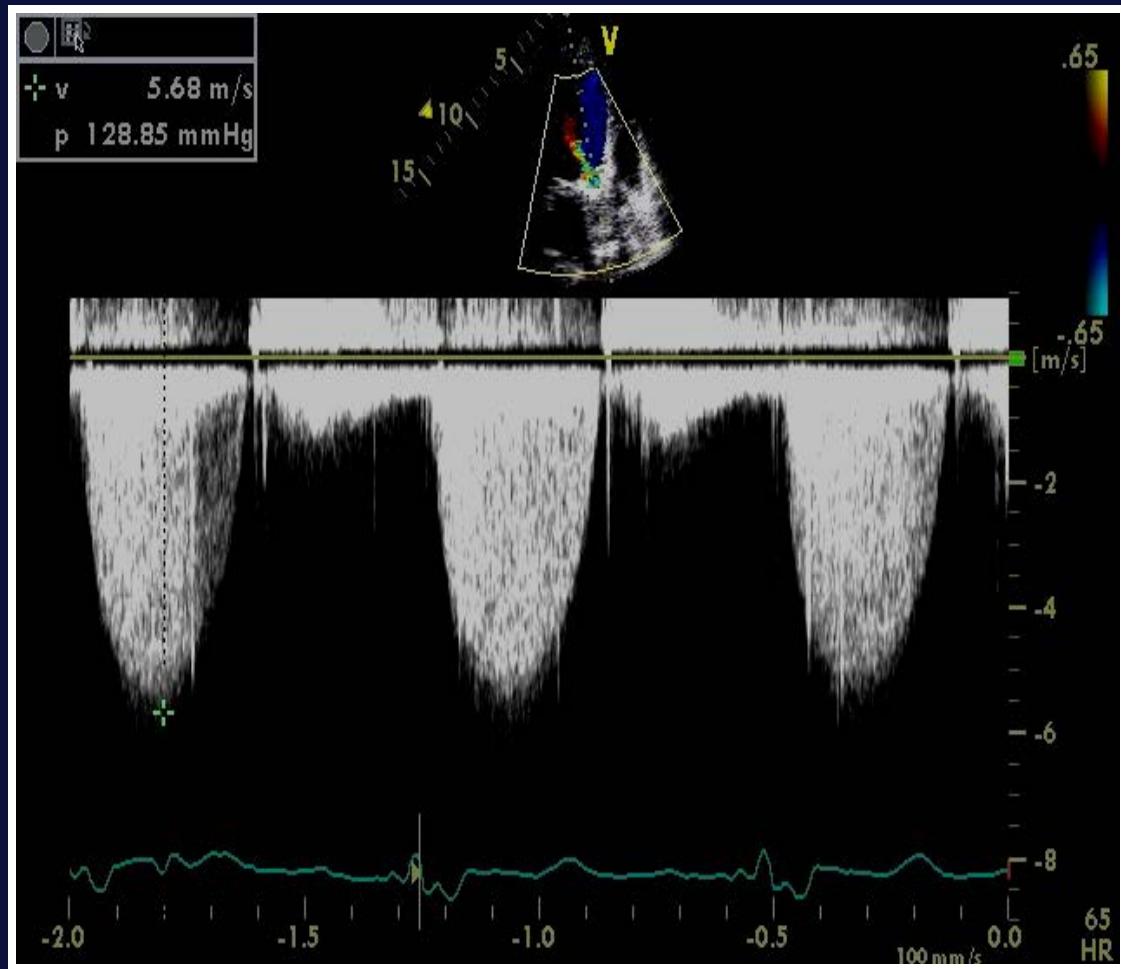
Our patient

Peak velocity 5.7m/s

Mean grad 68 mmHg

DVI 0.22

AT: 177 msec

Obstructed AVR

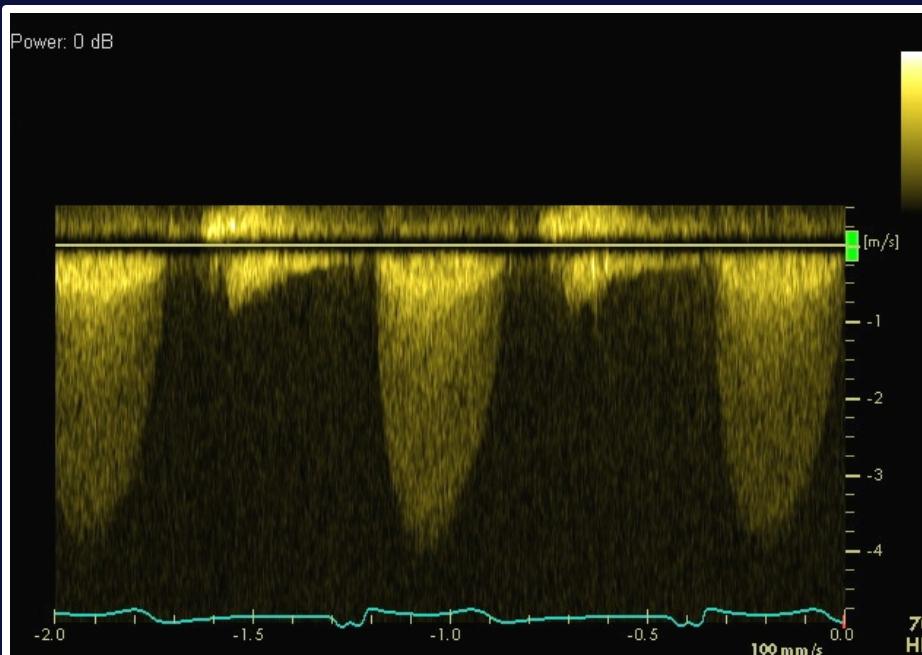
LVOT_{TVI} : 21

AS_{TVI} : 99
DVI: 21
EOA: 0.6 cm²
AT: 100 ms

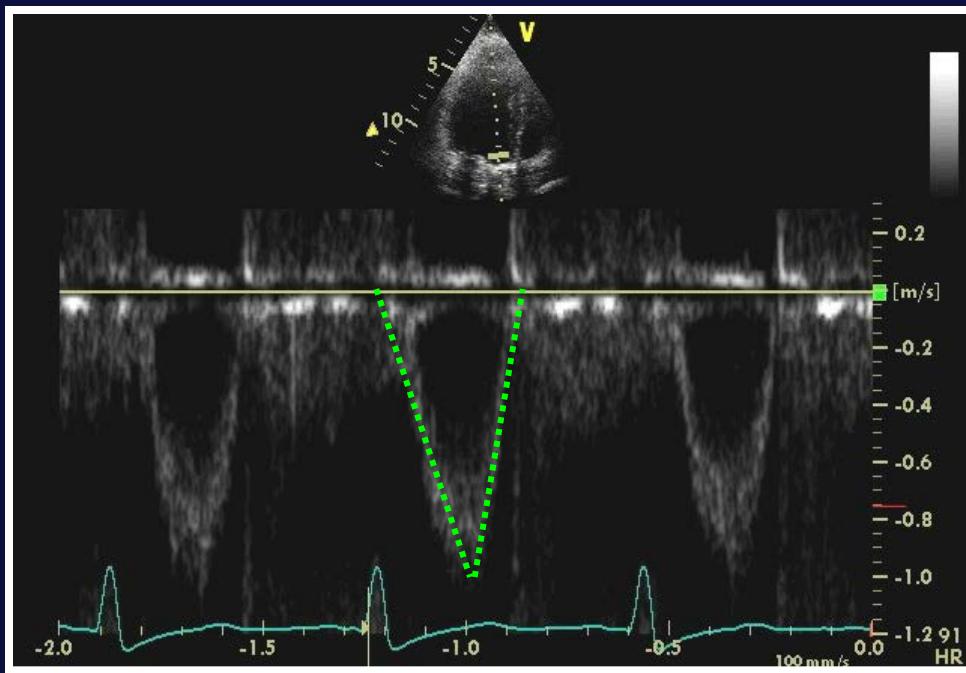
LVOT: 1 m/s

TVI_{LVOT}: 17.6

AV velocity: 3.4 m/s

DI: 0.27

Mean gradient
(mmHg): 30

EOA: 1.13 cm²
AT: 100 ms

Normal ATS #19

- Peak gradient: 47 ± 12.6 mmHg (46)
- Mean gradient: 25.3 ± 8 mmHg (30)
- EOA: 1.1 ± 0.3 cm² (1.13)
