# Ultrasound imaging artifacts: How to recognize them and how to avoid them

Echocardiography has become a critical tool in clinical cardiology in evaluating cardiac physiology and diagnosing cardiac disease states. However, imaging artifacts are commonly encountered and often lead to misdiagnoses of life-threatening diseases, such as aortic dissection and ventricular thrombus. It is, thus, critical for clinicians to understand these artifacts to avoid these misdiagnoses and protect patients from undue intervention. Artifacts can be broken down into two categories: those from violation of ultrasound system assumptions and those from interference by external equipment and devices. This review article discusses the most commonly encountered artifacts by category, explains their physical mechanisms, elaborates on their most common presentations, and instructs clinicians on how to avoid their misinterpretation.

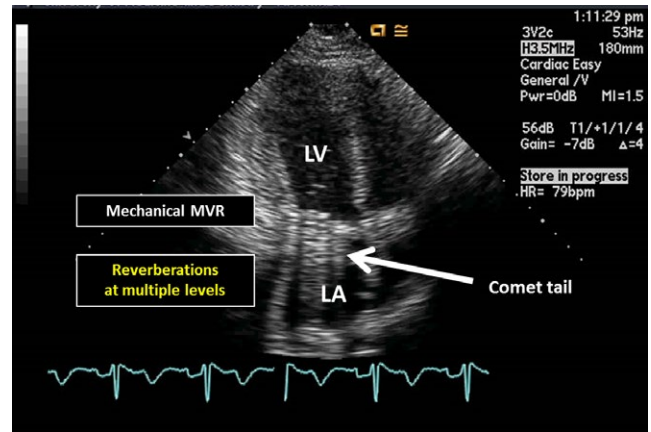
**FIGURE 5** (Corresponds to Movie S3). Comet tail artifact (white arrow) originating from a mechanical St. Jude mitral prosthesis. LA = left atrium; LV = left ventricle

The complex reverberation artifact, also known as the comet tail artifact, is produced in the same fashion as the simple reverberation artifact. In this case, though, there are usually two or more reflectors that are very close together, and the process involves multiple round trips. With each subsequent round trip, the artificial image produced is moved further below the original structure, and the signal intensity becomes progressively weaker. The characteristic appearance of the artifact is shown in Figures 5 and 6.

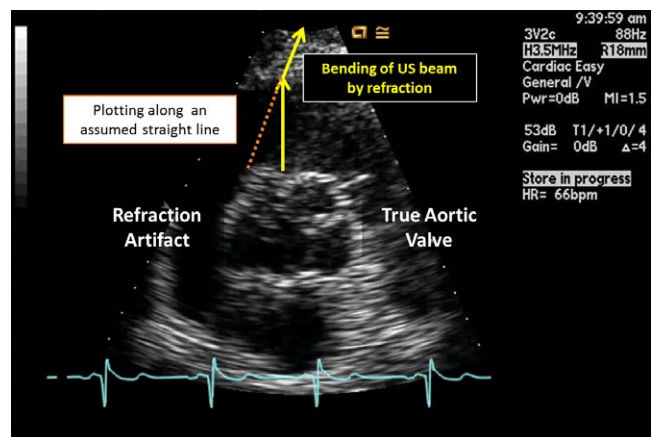
**FIGURE 13** (Corresponds to Movie S10). Demonstration of the altered path of the wave (dotted line), leading to refraction artifact showing duplication of the aortic valve

The refraction artifact violates the assumptions that the path of the ultrasound wave is straight and that the speed of the ultrasound wave is uniform. In this scenario, instead of the ultrasound wave traveling directly to the cardiac object and back to the transducer, the wave encounters a structure that acts as a wave refractor. This structure essentially behaves as a lens.<sup>42</sup> As the wave goes through the structure, the path of the wave is bent at the interface, and the speed of the wave is changed depending on material of the structure. This results in duplication (often partial) of the cardiac object that appears as a sort of ghost image to the side of the true image (Figure 13). The produced image is similar to that of the mirror image artifact, but it appears next to instead of underneath the true image. Common inducers of refraction artifacts are costal cartilage, fascial structures and fat, and pleural and pericardial surfaces.<sup>43,44</sup>

These artifacts are most often seen on the short-axis view of the aortic valve and left ventricle, but they are described only a few times in literature. When reported, they are commonly found depicting duplications of the mitral, aortic, or pulmonary valve.<sup>44,45</sup>
